ON-SITE AMBULANCE CRASH INVESTIGATION

SCI CASE NO.: CR12001

VEHICLE: 2007 FORD E450 CAB/CHASSIS

AMBULANCE BODY: HORTON TYPE III PATIENT COMPARTMENT

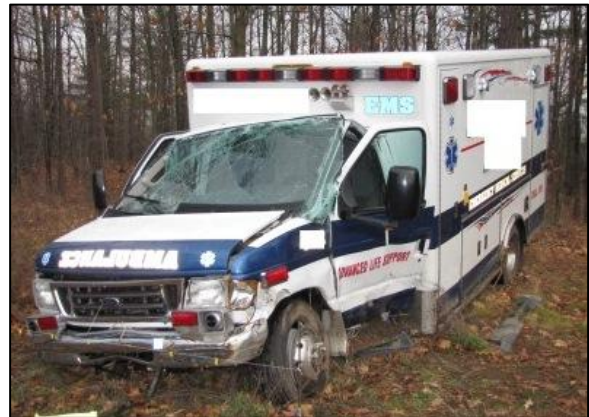
Figure 1. Front left oblique view of the Ford E450 ambulance.

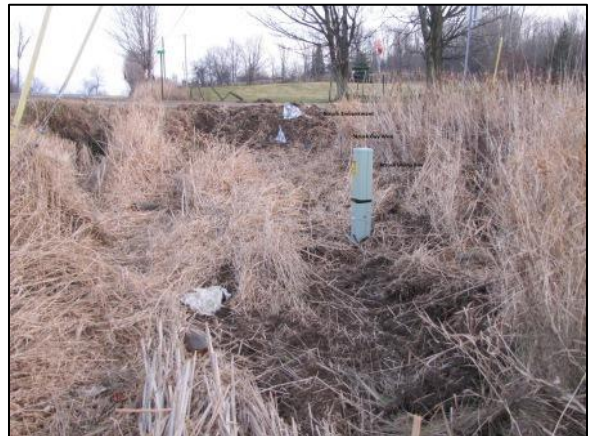
Figure 3. Ditch bottom and the objects struck.

The ambulance traversed the ditch bank and tracked along the bottom of the ditch as the right side tires furrowed into the ditch bottom. The furrowing into the ditch bottom produced a level of deceleration to the vehicle as it continued on an easterly trajectory. The front right aspect of the ambulance impacted and fractured a telephone splice box that located in the ditch bottom 20.2 m (66.5 ft) east of the struck mailbox location. Again, this 12 o'clock impact force did not alter or slow the ambulance. **Figure 3** is a view of the ditch and the objects struck.

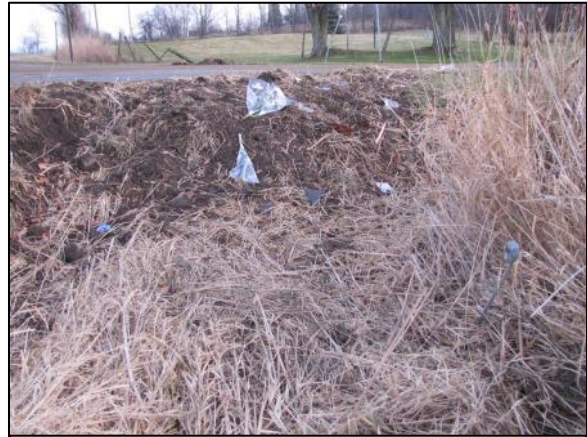
The ambulance continued forward and engaged the earthen embankment located at the east end of the ditch. The 1.2 m (4.0 ft) high embankment was comprised of soft dirt (**Figure 4**) that was displaced by the frontal and undercarriage planes of the ambulance. The embankment minimally displaced the frontal structure rearward, upward, and laterally right resulting in a force direction that was non-horizontal (00 o'clock). The right front tire and wheel separated from the axle spindle during the embankment engagement. The frontal air bags did not deploy during the long duration crash event and the safety belt buckle pretensioners did not actuate.

Figure 4. Struck embankment.

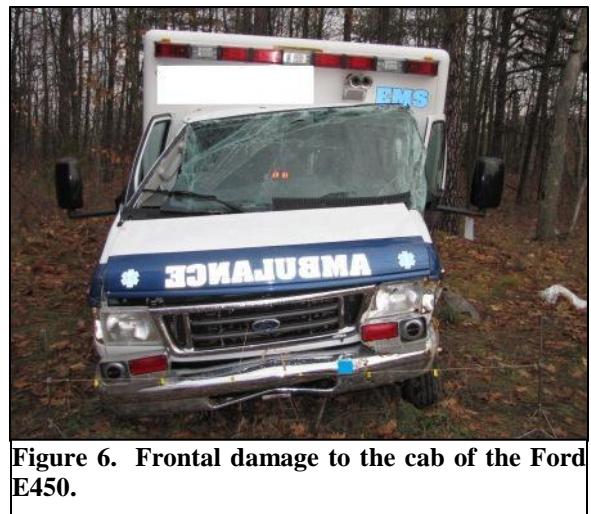
The Ford was involved in four impact events during this crash sequence (**Figure 6**). The initial impact involved the mailbox post at the west roadside. The post was fractured by the center right aspect of the front bumper; however, there was no direct contact evidence on the bumper associated with this event. The Collision Deformation Classification (CDC) was 12FZEU1.

Figure 6. Frontal damage to the cab of the Ford E450.

The leading edge of the right front fender impacted a cable guy wire for a utility pole. The guy wire was oriented parallel to the roadway. The impact separated the guy wire from either the ground mounting rod or the upper aspect of the utility pole. (The cable was removed from the scene prior to the SCI investigation.) The resulting damage to the Ford was located at the right edge of the fiberglass hood and the fender edge, beginning 89 cm (33.5 in) right of center and extending 8 cm (3 in) to the right corner. Centered within the area of direct contact and deformation was a lateral abrasion pattern associated with the cable. The depth of crush at this location was 3 cm (1 in). The CDC for this impact was 12FRMN1.

The fourth impact event was the most severe and was related to the earthen embankment. Post-crash, the slope of the embankment, although altered by the crash, was approximately 52 degrees. The front bumper and undercarriage engaged the embankment as the vehicle was deflected upward and climbed the embankment. The direct contact damage on the bumper was 172 cm (67.75 in), extending from corner-to-corner. The damage profile along the face of the

bumper was as follows: C1 = 4 cm (1.75), C2 = 2 cm (0.75"), C3 = 1 cm (0.25"), C4 = 0 cm, C5 = 0 cm, C6 = 0 cm. Maximum crush was located at the front left corner of the bumper.

The non-horizontal component of the impact force that involved the lower bumper and undercarriage deflected the frontal structure upward. A lateral shift also occurred to the front frame rails, displacing the structure to the right. The lateral displacement resulted in separation of the laminated windshield from both A-pillars, along the base of the glazing, and 38 cm (15 in) along the header, originating at the centerline, extending left.

The left wheelbase was reduced in length by 3 cm (1 in). The right front tire furrowed into the ditch bottom and heavily engaged the base of the embankment as the front wheels were turned in a clockwise direction. This resulted in a lateral loading to the inside surface of the tire and wheel. The threads of the castle nut at the outer end of the spindle stripped, separating the nut from the spindle. Consequently, the outer wheel bearing slid off the spindle, the brake rotor fractured, and the tire/wheel/hub separated from the vehicle. During the separation, the tire/wheel engaged the aft edge of the wheel opening, displacing the fender and aluminum running board rearward. The right wheelbase was reduced by 10 cm (4 in).

Superficial abrasions and mud were transferred onto both lower side surfaces as the Ford climbed the embankment. The CDC for the embankment impact was 00FDLW1.

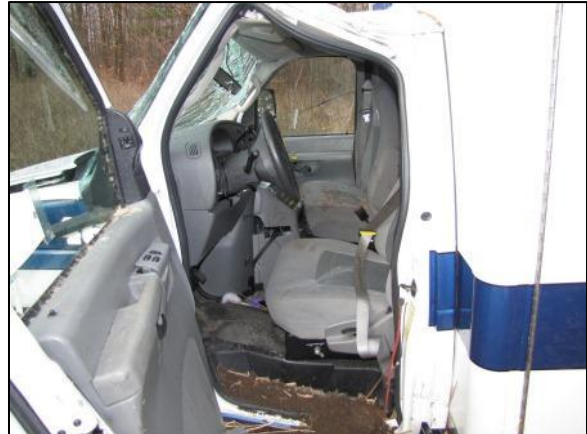
The interior damage to the occupant compartment of the Ford E450 chassis was limited to several intrusions, driver contact and blood transfers from the EMT that was initially seated in the patient compartment. The intrusions consisted of 6 cm (2.5 in) of rearward displacement of the left A-pillar (measured at the level of the striker plate) and left mid instrument panel. The right A-pillar was displaced 4 cm (1.5 in) rearward and resulted in a matching displacement of the right mid instrument panel. The left floor pan buckled downward at the left side of the engine cover, exposing the transmission casing. The engine cover was partially separated from its attachment points and engaged the left leading aspect of the front right passenger seat. Figure 7 is an overall view of the driver compartment and cab of the Ford E450.

Figure 7. Overall view of the driver compartment and cab of the Ford E450.

Both front door latches released from stress overload during the engagement with the embankment as the A-pillars displaced rearward.

The driver, although belted, loaded the right upper quadrant of the steering wheel rim. This subtle loading did not deform the wheel rim or spokes, but deformed the mounting flange. The gap between the steering wheel hub and the column was minimally closed at the upper right quadrant area.

The knee bolster panel partially separated at the right attachment point due to A-pillar/instrument panel displacement. There was no loading evidence associated with driver contact.

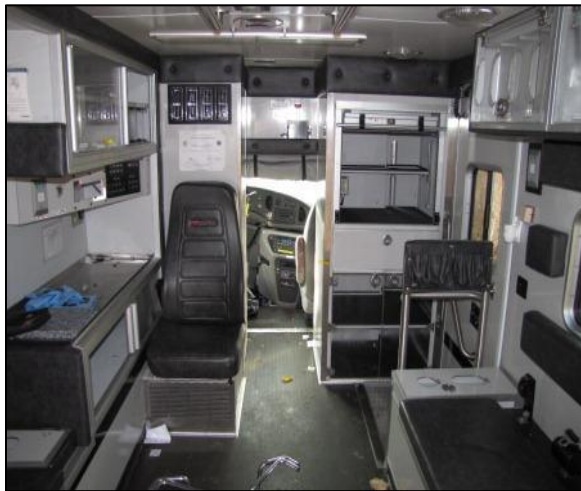
There were occupant contact points within the patient compartment. Blood evidence was present on the sides of the pass through to the cab of the ambulance and around the left microphone area as the male EMT called to request assistance. The stretcher was removed from the ambulance and was stored at a separate location. **Figure 8** is a view of the ambulance as found at the time of the SCI inspection. **Figure 9** is a view of an exemplar ambulance with all equipment in place and displayed.

Figure 8. Forward view of the patient compartment and blood evidence within.

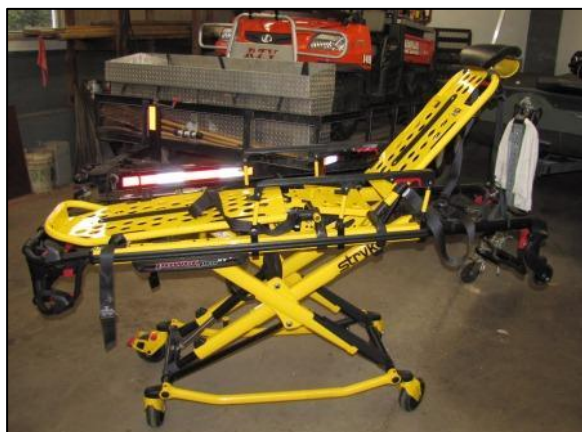
During the crash sequence and primarily at impact with the embankment, the patient loaded the backrest of the stretcher. Although the restraints held the patient in position on the stretcher, his loading force was translated into the frame of the stretcher. A cross tube that was located in the area of his pelvic region was stressed vertically. The polymer rackets that secured this tube fracture on the bottom aspects allowing the tube to separate from its pivot points. The perforated aluminum tray located directly rearward of this cross tube deflected upward, deforming the tray at the area of the patients upper thighs. The forward pivot arm for the side rail at the patient's left side was minimally deformed. This possibly resulted from the patient or EMT loading

Figure 10. Overall view of the stretcher with the backrest positioned semi-Fowler.

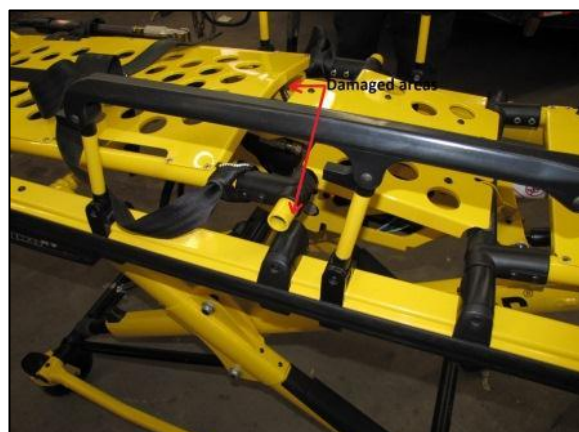
during the crash or from the post-crash removal of the stretcher from the patient compartment. Although the stretcher did sustained damage, its overall integrity was maintained and it remained in its locked position. **Figure 10** is an overall view of the stretcher and **Figure 11** is a close-up of the loading damage to the mid frame area.

Figure 11. Separation of the stretcher cross member and deflection of the lower extremity pan.
